Inspection Report Re: Alpaca Fir

From: David Maxfield <damaxfield370@gmail.com>
Subject: Blooma Tree Service Inspection Report
Date: November 21, 2025 at 1:16:22 PM PST
To: Helen Gabel <helengabel@gmail.com>
Cc: Phil Notermann <phil.notermann@gmail.com>

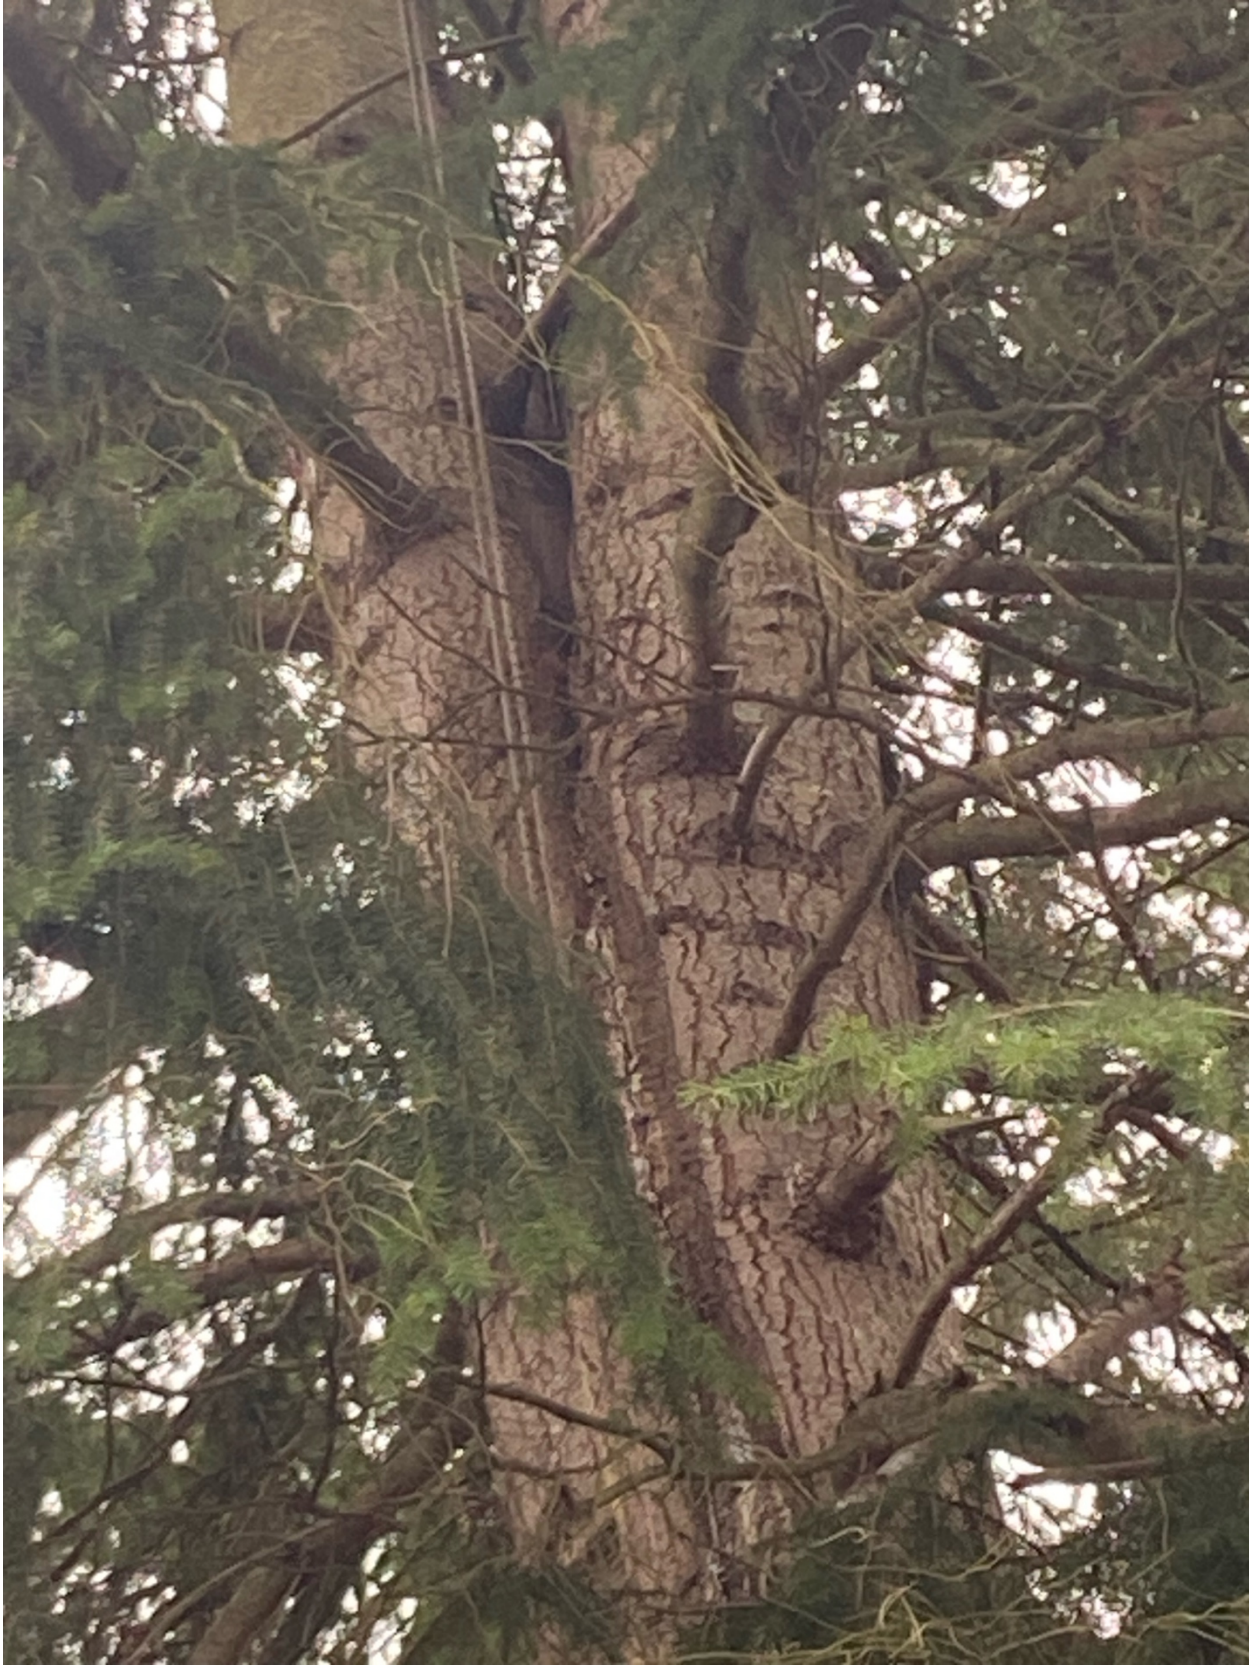
The verbal report is that the tether cable is in good shape. No sign of corrosion. The tree is encapsulating the cable nicely. However, the junction itself is of some concern. They recommend in the next five years, a bolt should be placed in the junction to prevent a shear failure. In addition, the non-dominant, south fork, should be lightened to reduce the load on the junction. Not an immediate concern, but should be on our list for the next round of tree work.

Note: photo below taken during inspection by me from back yard at Alpaca. Also, I thought I had the impression that the north fork was the non-dominant.
--Helen Gabel
